W6: Ultrasound in the Investigation of Female Pelvic Organ Prolapse

The use of translabial ultrasound in women with pelvic floor disorders

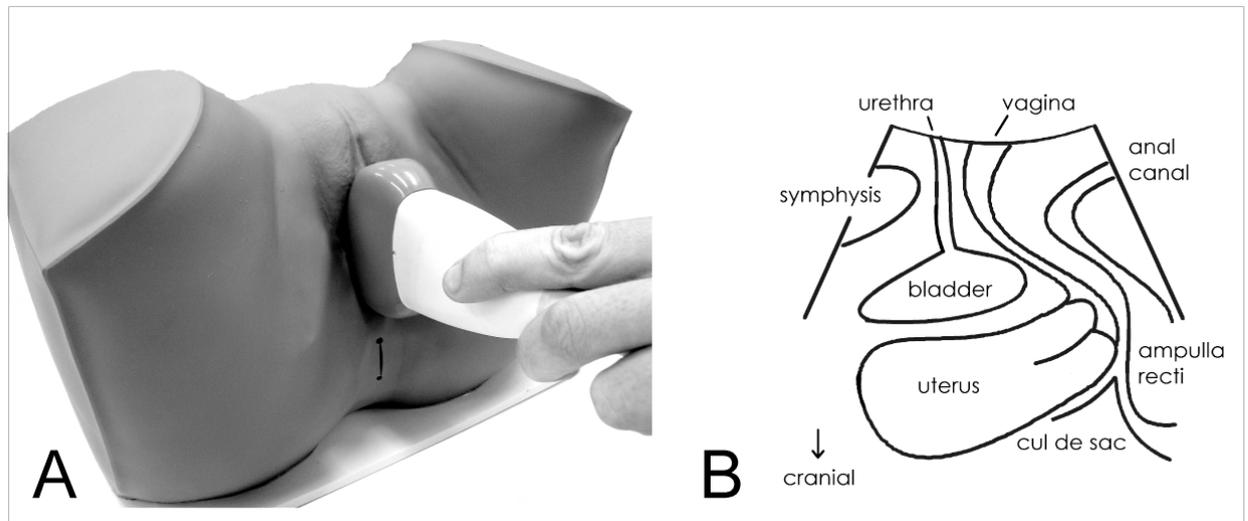
Figure 1: Standard transducer placement for translabial ultrasound (A) and image orientation in the midsagittal plane (B).

Imaging plays a growing role in the investigation of pelvic floor disorders, especially translabial or perineal ultrasound. With this method most structures of interest in pelvic floor disorders can be observed in the near field, at high frequencies, and with sufficient clarity due to excellent tissue discrimination between urethra, bladder, vagina, anorectum and levator muscle. It is performed by placing a curved array 2D or 3D transducer on the perineum (Figure 1).

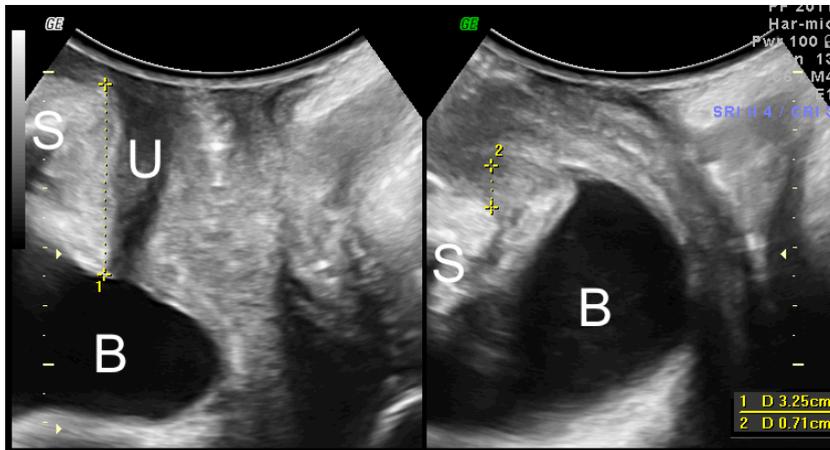
Figure 2: Bladder neck descent (BND) measured on translabial ultrasound (rest at left, on Valsalva on right). S= symphysis pubis, B= bladder, U= urethra. BND = 3.96 cm.

The original indication for translabial or transperineal ultrasound was (and still is) the determination of **bladder neck mobility** (Figure 2). This is done against the reference of either the inferior margin of the symphysis, or against the central axis of the same. The former is more convenient, the latter may be marginally more repeatable. However, modern systems allow much more than determination of bladder neck mobility. Mobility of the entire urethra can be determined, which has shown that it is the **mid-urethra**, rather than the bladder neck, that matters most for stress continence, and that pregnancy, rather than childbirth, influences this parameter.

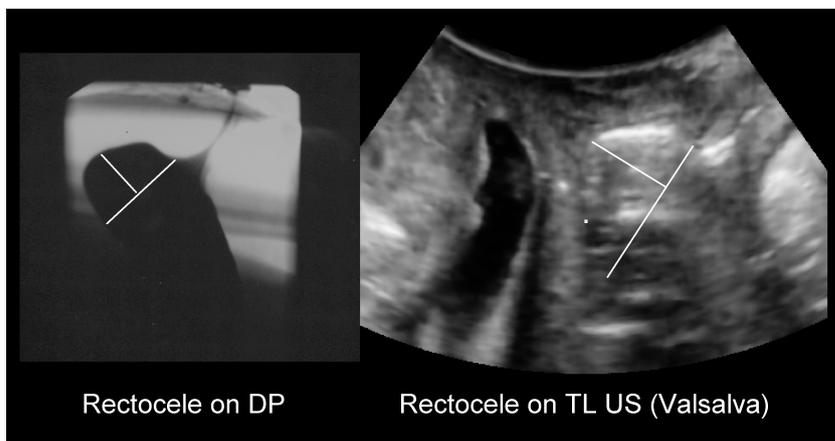
Figure 3: Rectocele imaged by defecation proctography (left) and translabial 2D ultrasound (right).

A Stage II rectocele observed on clinical examination could be due to a **true rectocele** (Figure 3), i.e., a defect of the rectovaginal septum (most common, and associated with symptoms of prolapse, incomplete bowel emptying and straining at stool), due to an abnormally distensible, intact rectovaginal septum (common and associated only with prolapse symptoms), a combined **recto- enterocele** (less common), an isolated **enterocele** (uncommon), or just a deficient perineum giving the impression of a 'bulge'. Occasionally a 'rectocele' turns out to be a **rectal intussusception**, an early stage of **rectal prolapse**, where the wall of the rectal ampulla is inverted and enters the anal canal on Valsalva. In addition, this form of imaging can provide information on the anal canal and sphincter at no additional cost or inconvenience (Figure 4).

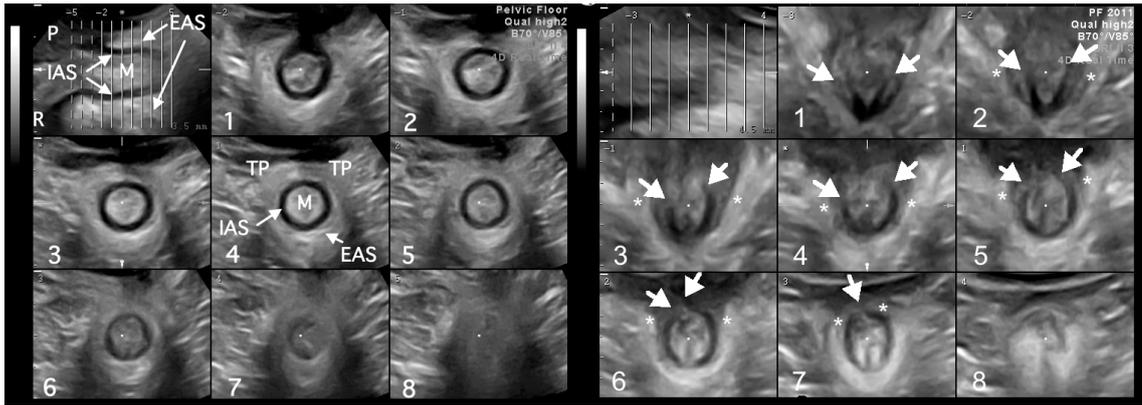
Fig. 4: Anal sphincter imaging with translabial tomographic ultrasound. The left hand panel shows an intact sphincter, the right hand panel demonstrates both external (*) and internal (arrows) sphincter defects.

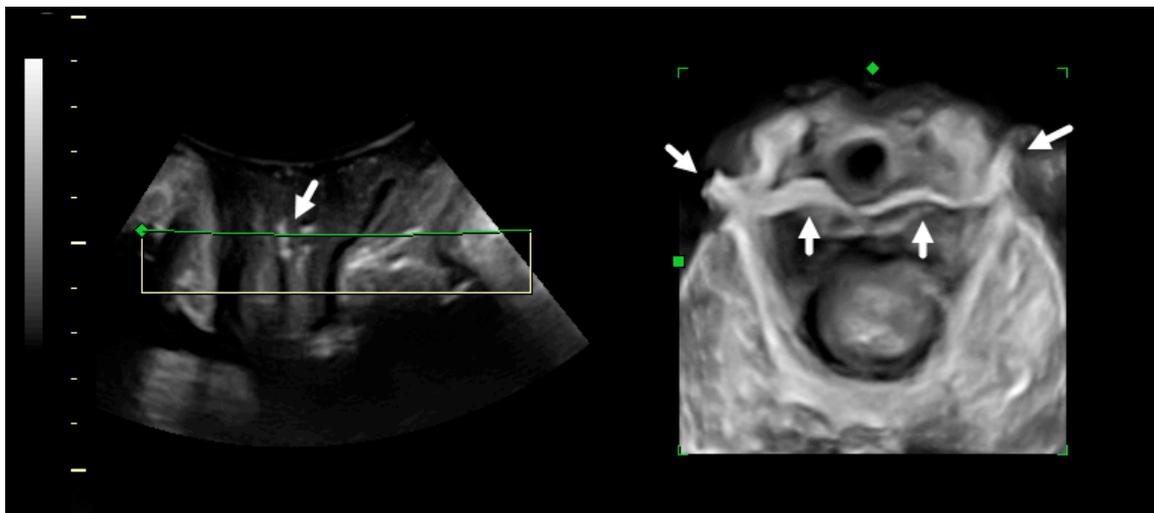
Figure 5: A transobturator tape (arrows) as seen in the midsagittal plane (left) and in the axial plane (right).

Since the late 1990s synthetic **suburethral slings** have become very popular. Ultrasound can confirm the presence of such a sling, distinguish between transobturator and transretzius implants, especially when examining the axial plane (see Figure 5), and allow an educated guess regarding the type of implant. As these meshes are highly echogenic, ultrasound is superior to MR in identifying implants and has helped elucidate their mode of action. It is also very helpful when assessing women with complications of suburethral slings such as voiding dysfunction and de novo symptoms of urgency, helping the surgeon to decide whether to cut a sling.

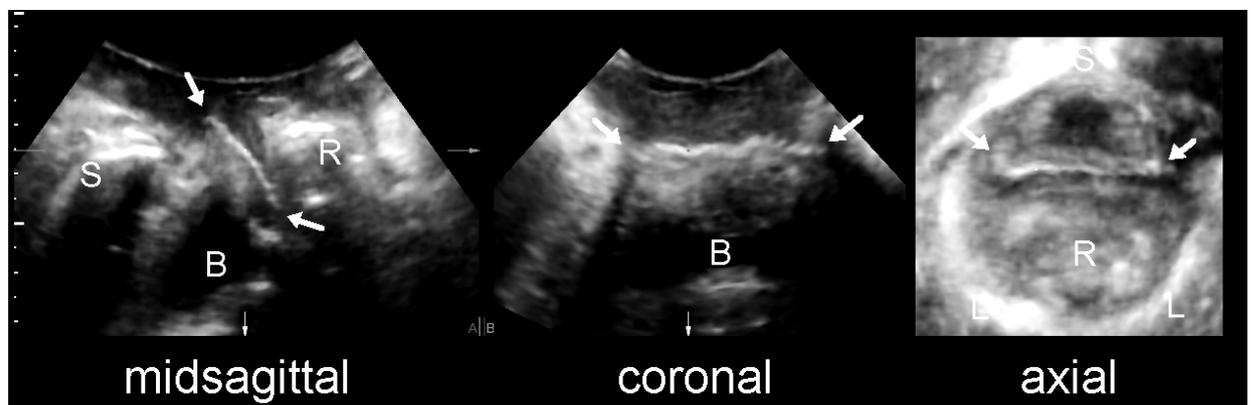
Fig. 6: A transobturator mesh, as seen in the midsagittal (left), coronal (middle) and axial plane (right).

erosion and chronic pain are not that uncommon. Polypropylene meshes are highly echogenic (see Figure 6), and their visibility is limited only by persistent prolapse and distance from the transducer.

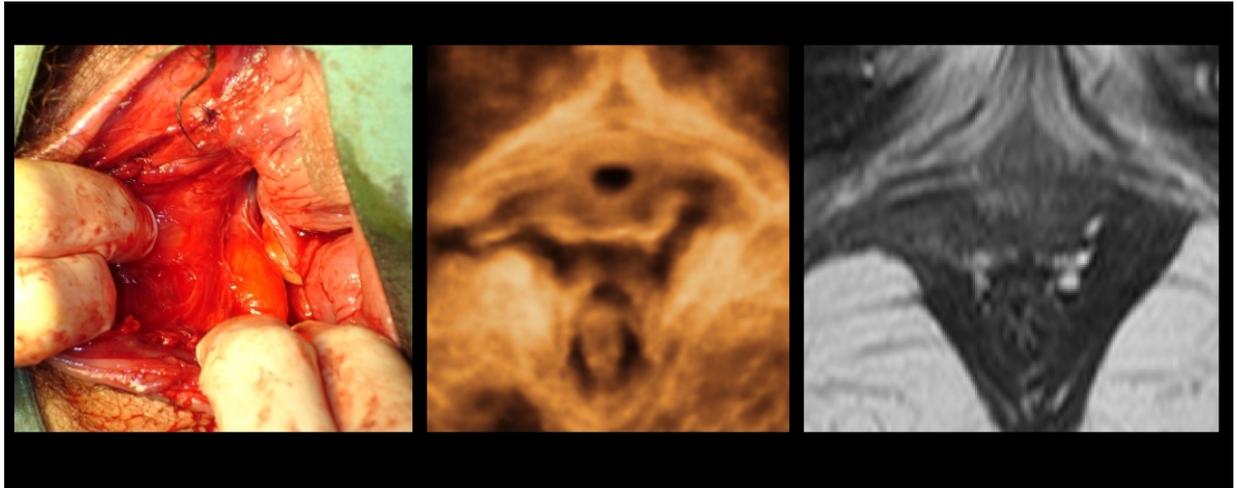
Fig. 7: Typical right-sided avulsion of the puborectalis muscle as seen in Delivery Suite (left), on translabial 4D US (middle) and on MR (right).

Major delivery-related trauma of the puborectalis muscle ('**avulsion**', see Figure 7) is a major factor in the aetiology of female pelvic organ prolapse. It occurs in 10-30% of first vaginal deliveries, more commonly after Forceps and in older primiparae, and is strongly associated with **cystocele and uterine prolapse**, and with **recurrence** after prolapse surgery. Avulsion reduces pelvic floor muscle function by about one third and has a marked effect on hiatal biometry and distensibility. In the past it was generally assumed that abnormal muscle function was due to neuropathy, but damage to the innervation of the levator ani muscle is likely to play a much smaller role compared to direct trauma.

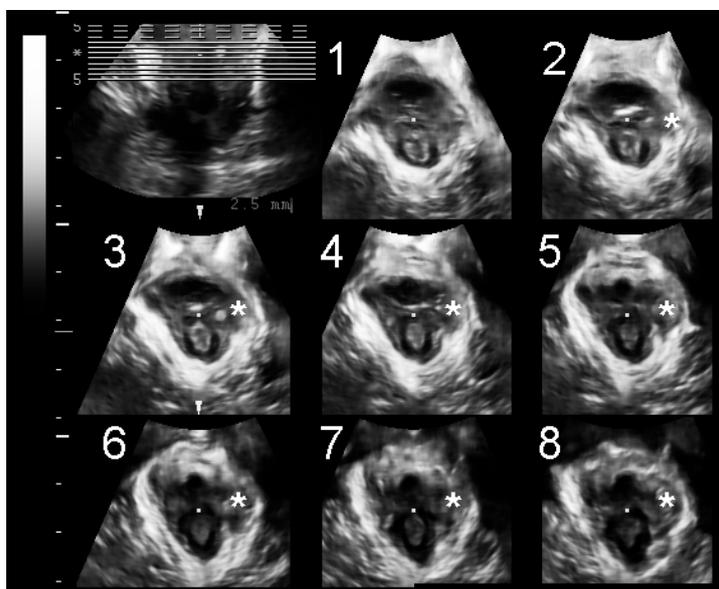
Figure 8: Translabial tomographic imaging of a unilateral avulsion, with all panels abnormal on the right (*), ie., the patient's left hand side.

These defects are palpable, but palpation requires significant teaching and is clearly less repeatable than identification by ultrasound. Identification of an avulsion injury is aided by measurement of the '**levator- urethra gap**', the distance from the center of the urethral lumen to the most medial aspect of the puborectalis muscle, and **tomographic US** is particularly useful (see Figure 8).
